RCRA FACILITY ASSESSMENT REPORT  
FOR  
DICO OIL CORPORATION

EPA ID NO. CAD980737076

JUNE 1994

PREPARED BY:  
CALIFORNIA ENVIRONMENTAL PROTECTION AGENCY  
DEPARTMENT OF TOXIC SUBSTANCES CONTROL  
1011 NO. GRANDVIEW AVENUE  
GLENDALE, CALIFORNIA 91201

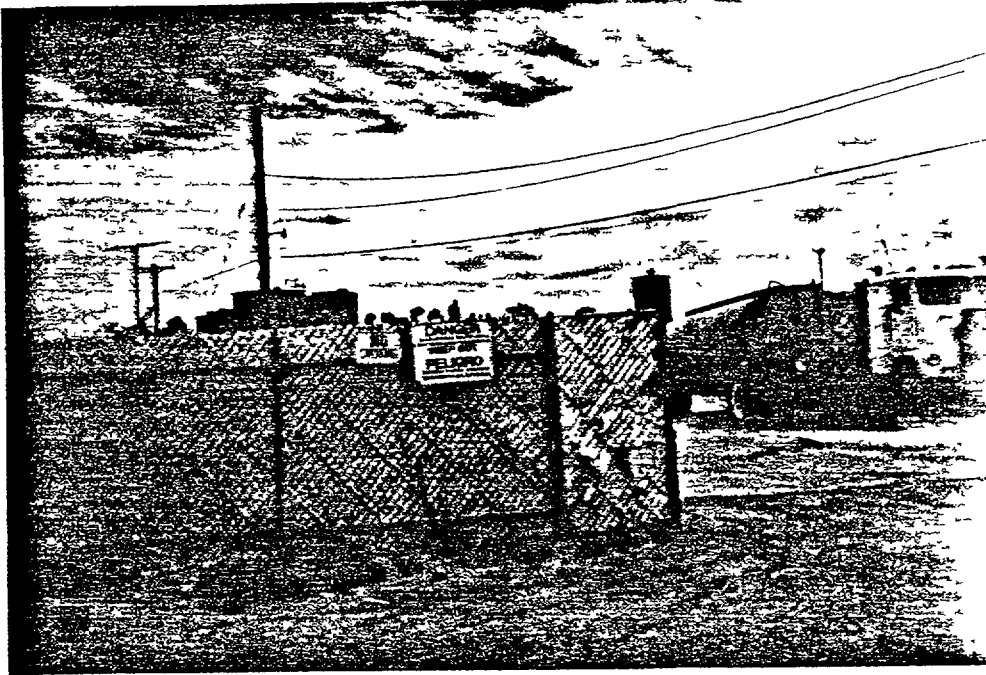
Photo No. 1 This photograph is an entrance to the facility. Notice the facility has a hazardous waste facility sign posted.

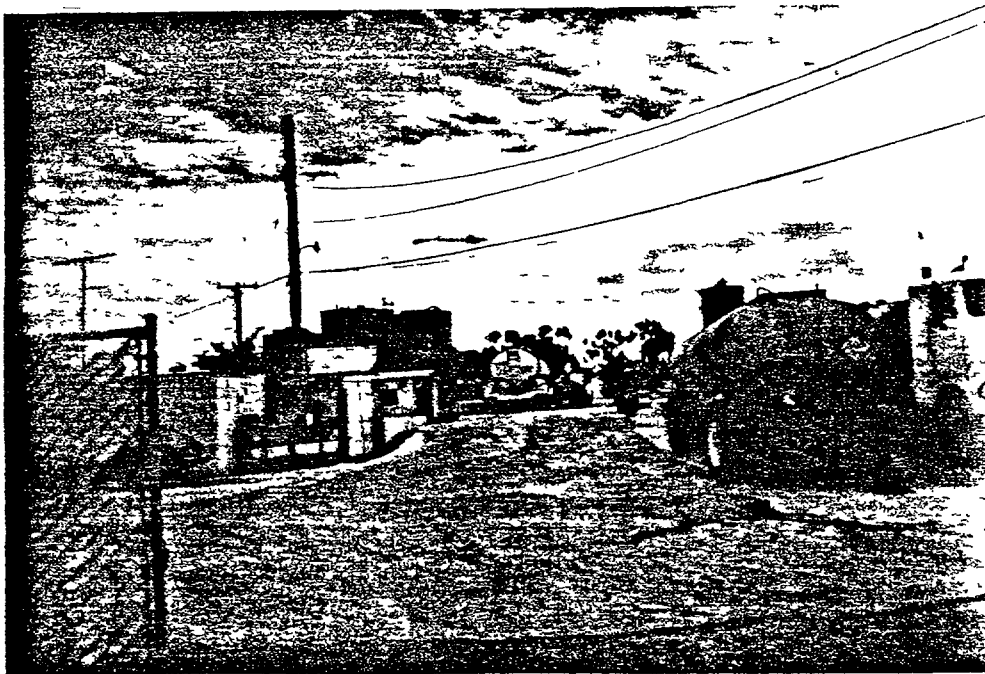
Photograph No. 2 This is a view of the facility 1 looking South. Notice the facility is situated on a slight incline.

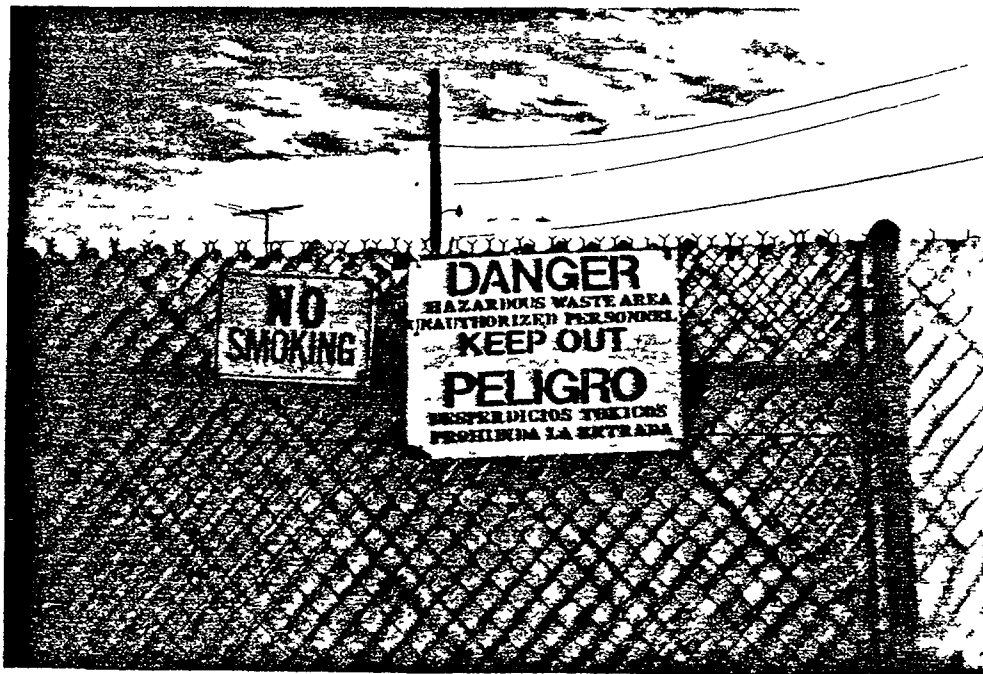
Photograph No. 4 Upclose view of the Hazardous Waste sign posted outside the facility.

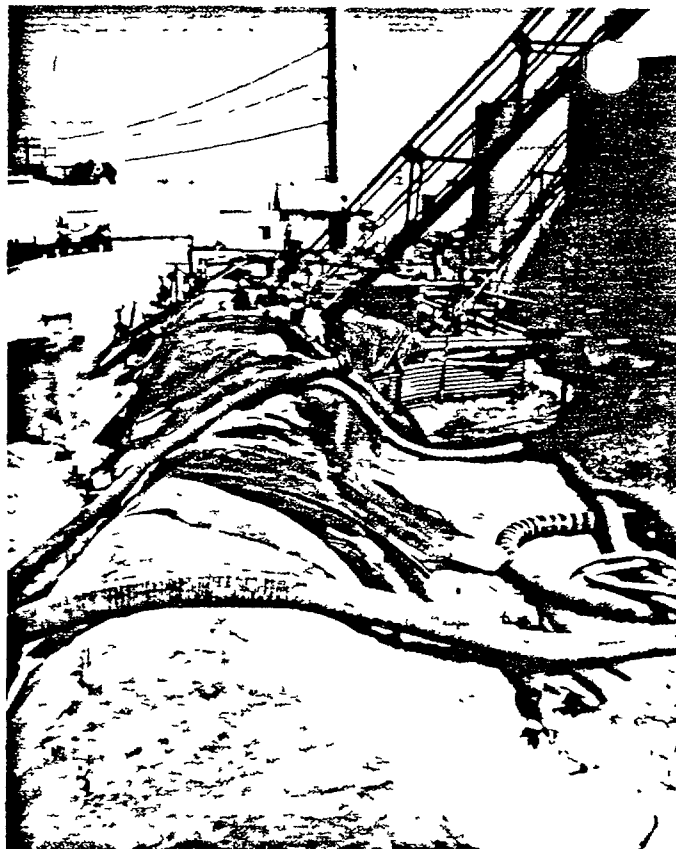
Photo No. 29      Contaminated soil berm covered with visouene (SWMU No. 11) looking north from west side of tank farm facility.

Photograph No. 29 This is a photograph of the Contaminated Soil Berm which surrounds the facility (SWMU No. 11). This view is looking North-west. Notice the berm is covered with visquene.

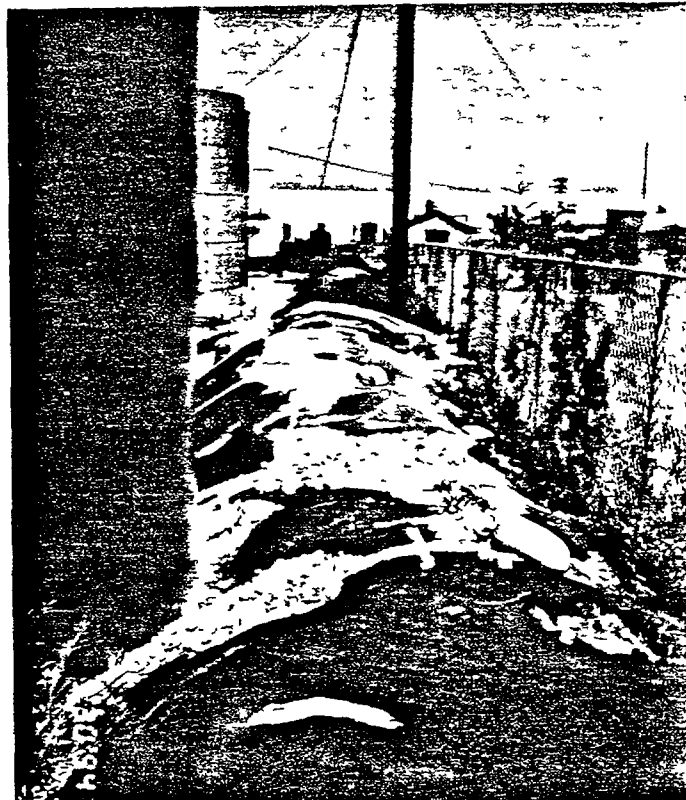
Photograph No. 30 This is a photograph of the Contaminated Soil Berm which surrounds the facility (SWMU No. 11). This view is looking north-east. Notice the berm is covered with visquene.

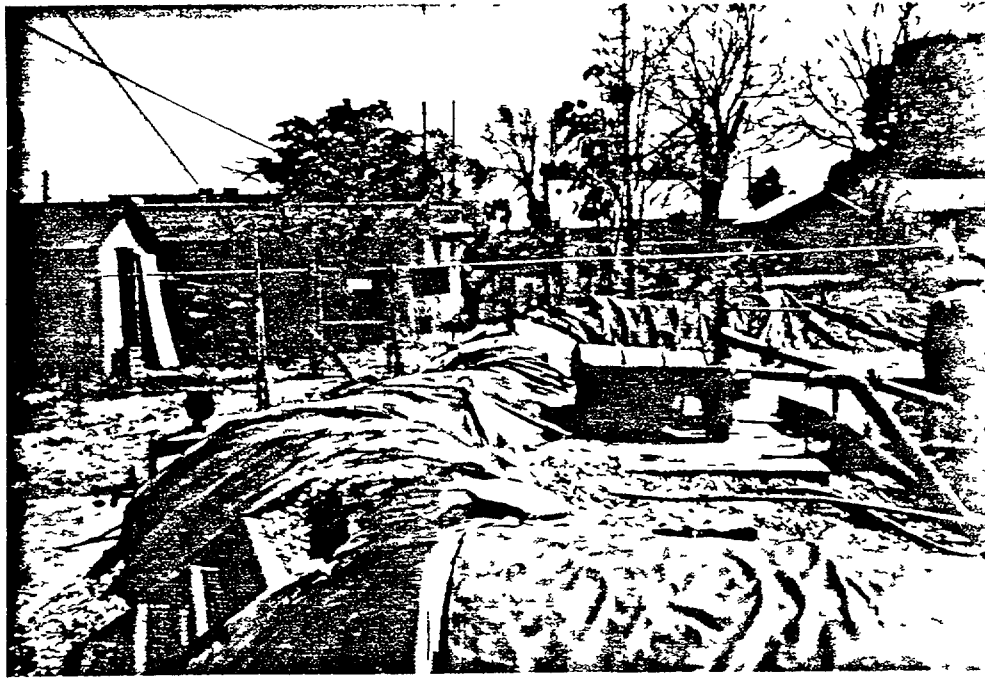
Photograph No. 31 This is a photograph of the Contaminated Soil Berm which surrounds the facility (SWMU No. 11). This view is looking south-east. Notice the berm is covered with visquene.

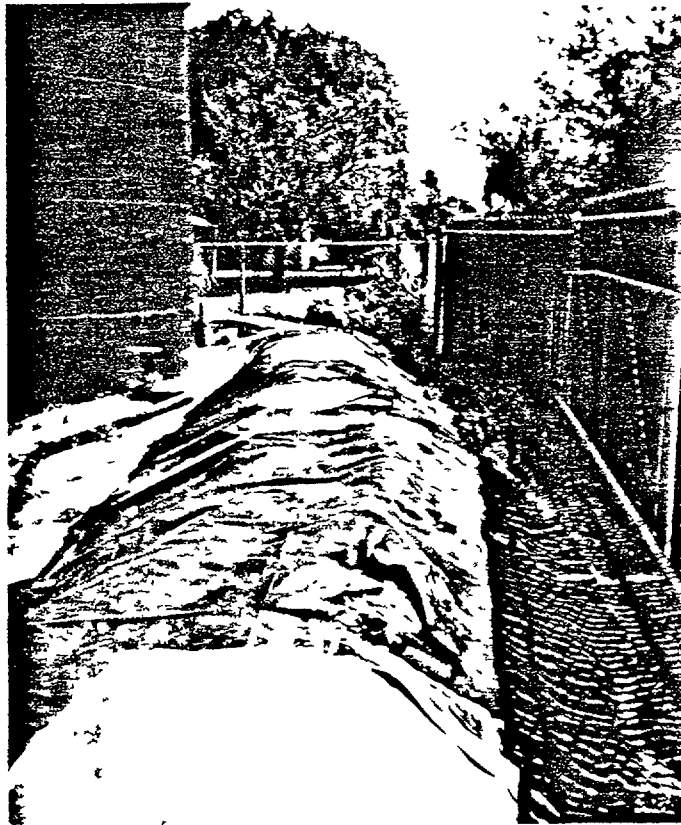
Photograph No. 32 This is a photograph of the Contaminated Soil Berm which surrounds the facility (SWMU No. 11). This view is looking south-west. Notice the berm is covered with visquene.

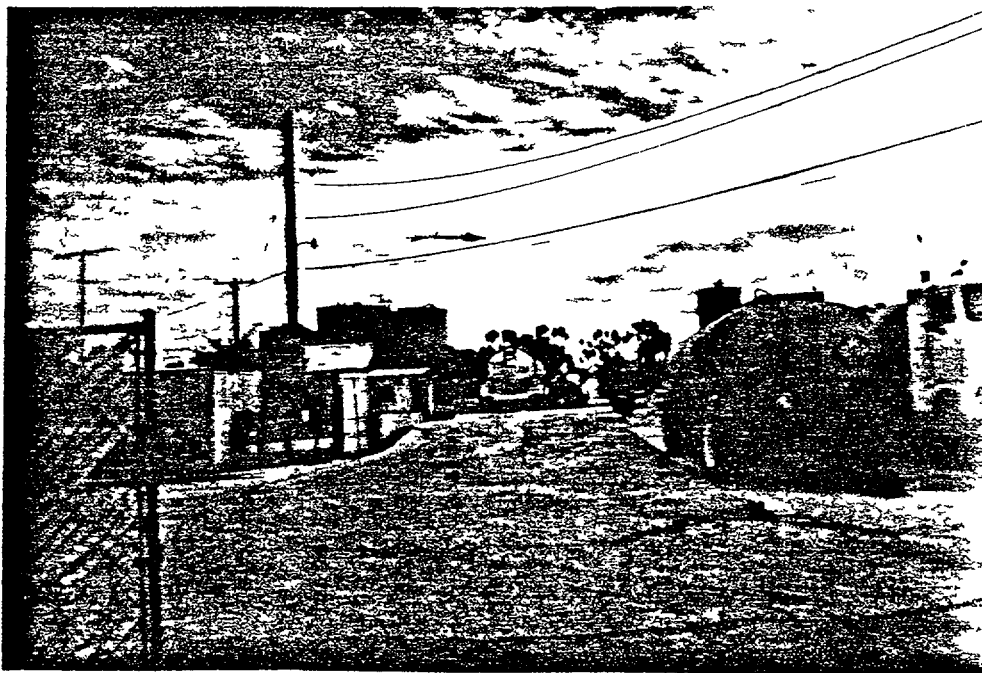
Photograph No. 34 This is another view of the Truck Loading/Unloading area within the facility (SWMU No. 12). This view is looking south from the entrance of the facility.

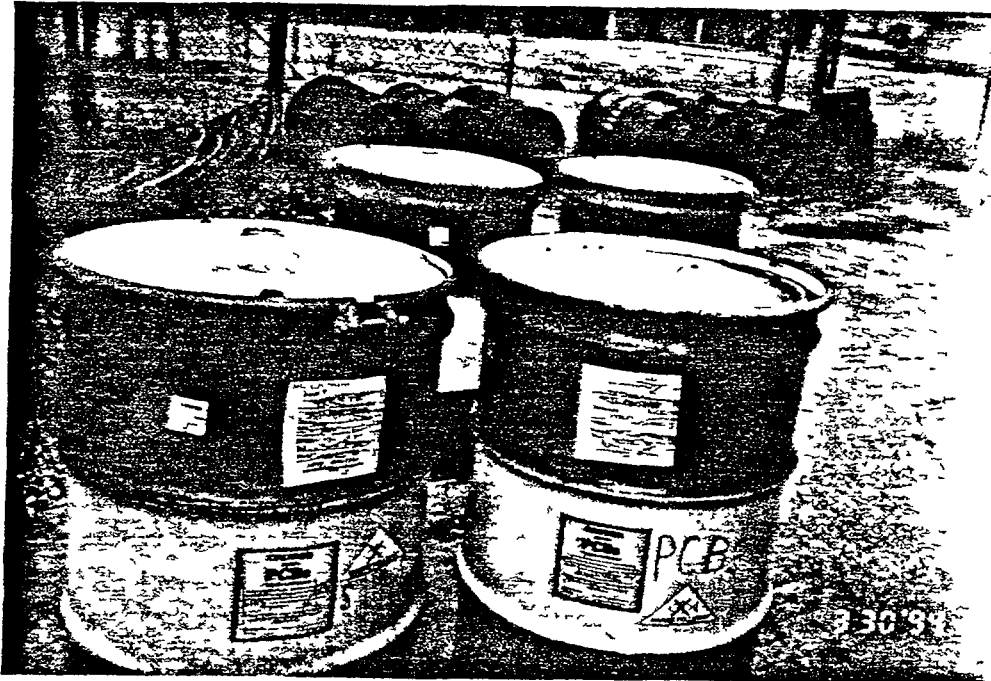
Photograph No. 43 This is a photograph of four drums of polychlorinated biphenyl (PCBs) contained within the drum storage area (SWMU No. 15).

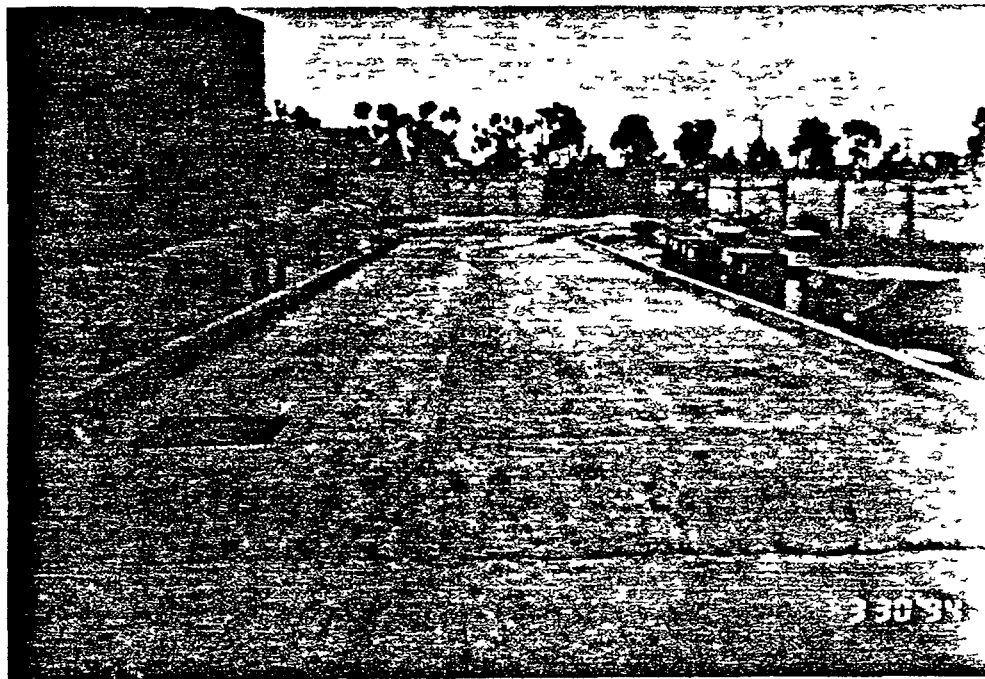
Photograph No. 49 This is a photograph of the Sump contained within the Truck Loading/Unloading area within the facility (SWMU No. 19). This view is looking south.

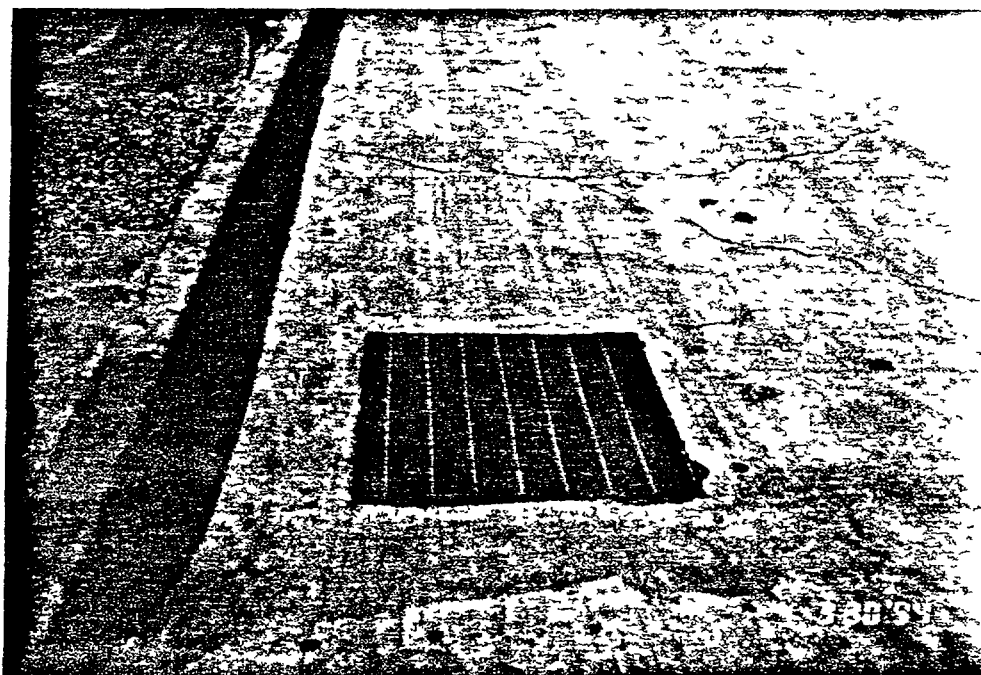
Photograph No. 50 This is a close up view of the Sump contained within the Truck Loading/Unloading area within the facility (SWMU No. 19). This view is looking south.

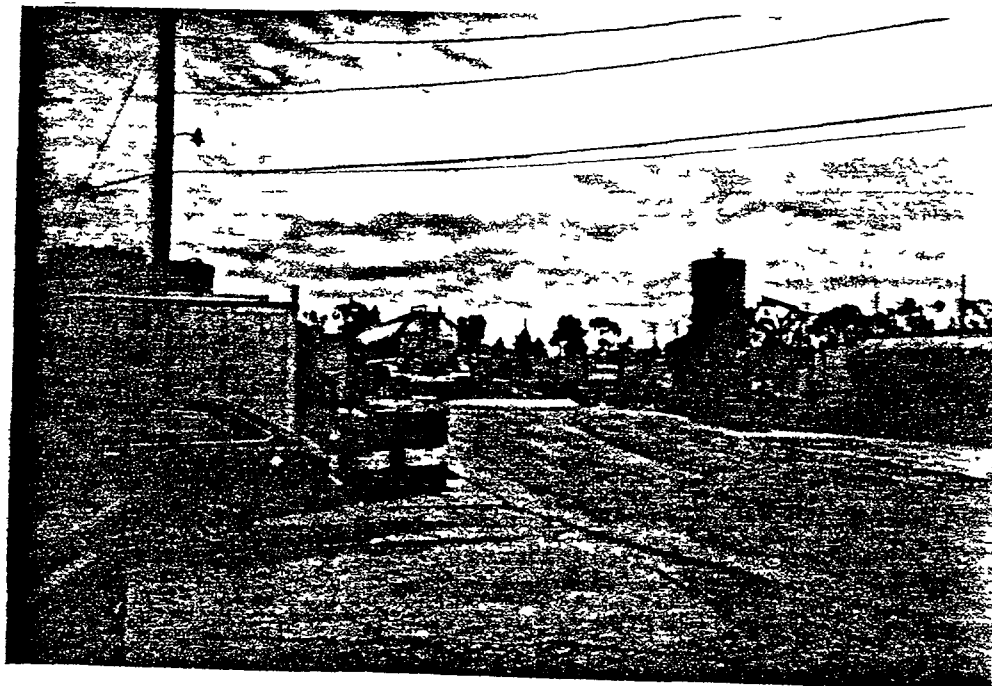
**Photograph No. 52** This is a photograph of two water tanks (right side of photo), used for emergencies that may occur at the facility.

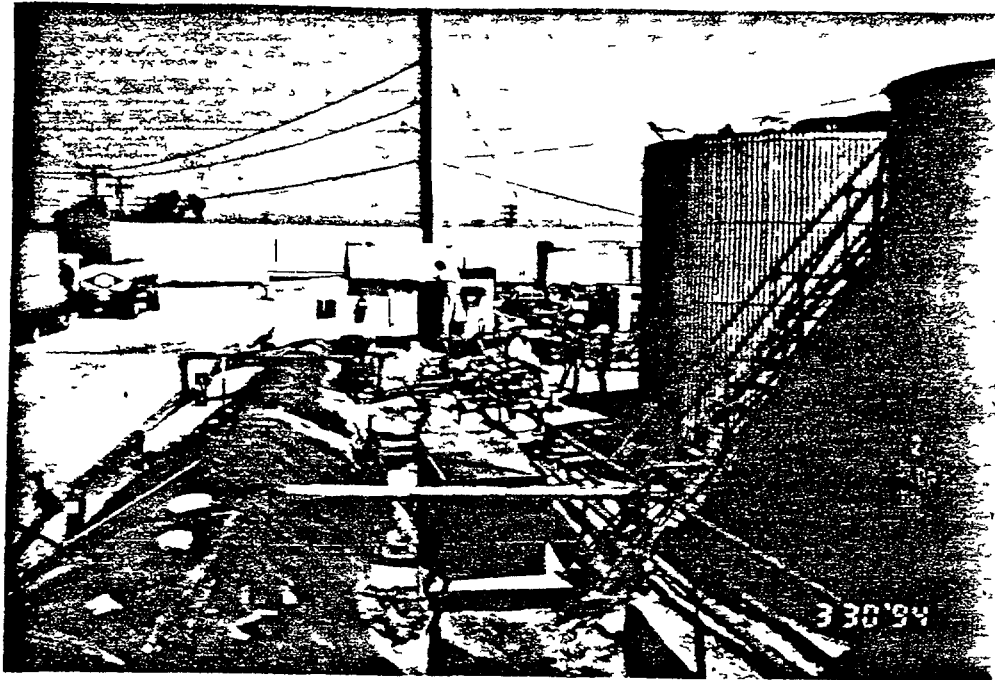
Photograph No. 53 This is a photograph of a 110 gallon tank used for oil storage from spills that may occur during Loading/Unloading area within the facility. Notice the tank is placed on a concrete pad.
